Body Leaks – Karmann Ghia Models

Slide Series No. 14

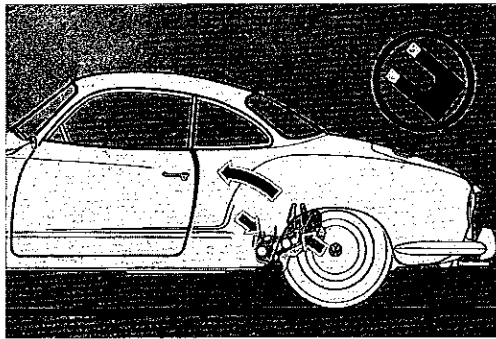
14/2 Before spraying the car check whether exterior leaks are visible.

Here you see that the rear door gap is wider in the upper region whereas the gap between door and side panel is parallel. This goes to show that the body has settled at the rear. It would be incorrect in this case to re-adjust the door hinges.

To be on the safe side we remove the striker plate and check whether the door fit alters.

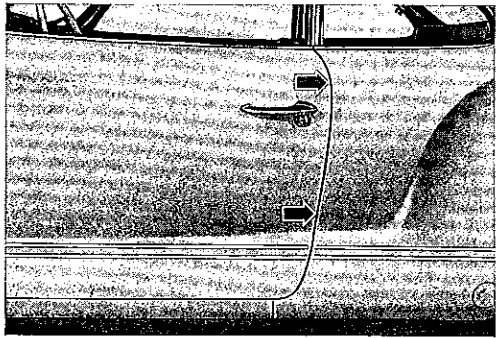
14/3 If this is not the case, the rear of the body must be raised until the gap between door and quarter panel is parallel.

To this end the bolts shown by the arrows should be loosened approximately 5 turns. Insert the synthetic packing shown in the circle into the gap at the right-hand bolt. Finally tighten both bolts to the prescribed torque:

Bolt M 10 to 2 mkg (14 ft.lbs.)

Bolt M 8 to 1.2 mkg (9 ft.lbs.)

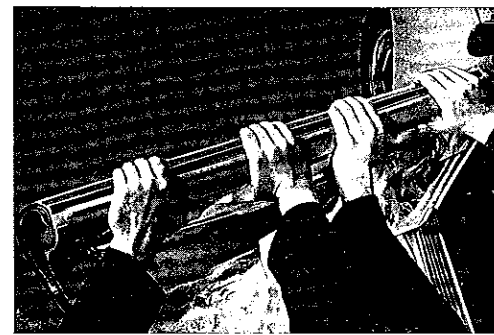
14/5 This weatherstrip is wavy and is not seated correctly on the glass. It must, therefore, be replaced. The removal and installation must be carried out carefully to prevent damage to the paintwork.

If the weatherstrip still does not seat correctly, correction should be carried out at the window channel.

This picture shows you how to do this.

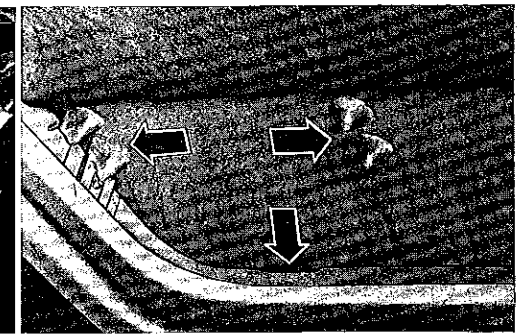
14/6 We remove the weatherstrip and the window glass. Two mechanics press the window channel together. The door must be pressed from the inside to avoid denting the door on the outside.

Check the seating of the weatherstrip on the window after installing the window and weatherstrip. Repeat the procedure if the weatherstrip still is not correctly seated.

Finally the pressure of the plastic buffers on the window must be set uniformly.

Make sure that the buffers do not press too heavily on the window as otherwise the glass will become scratched.

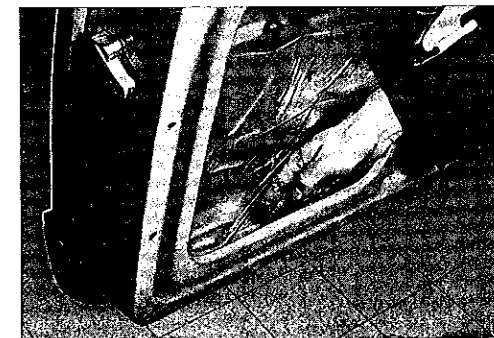
14/7 In the event of door leaks always check whether the three drain holes in the bottom of the door have become blocked by dirt.

When driving fast, water is sucked up and collects in the front region between scuff plate and door.

Both of the rear drain holes — one of which is shown by the lower arrow — should be cleared and enlarged. The front drain hole should be sealed up with sealing compound, an operation which is now being carried out in current production.

Finally check whether the mounting noses for the mouldings on the door — shown by the upper arrows — are correctly sealed.

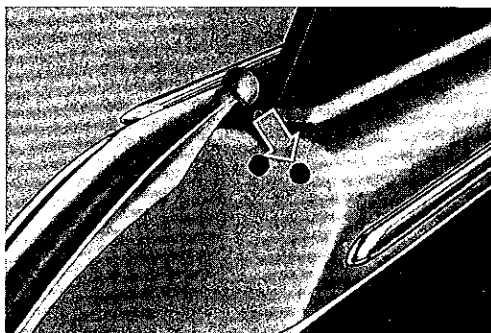
14/10 The small arrows on the lock pillar show the direction water will flow if it enters at the location indicated by the large arrow. If a leak occurs here, the carpet at the end of the scuff plate will become damp.

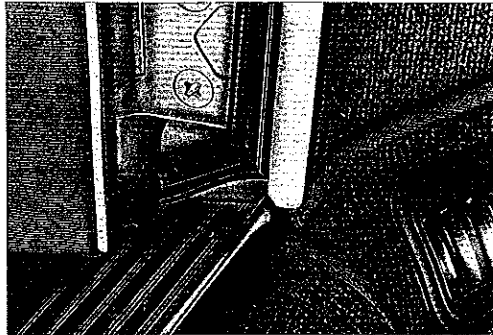
14/17 In this picture you see that the angled part of the weatherstrip is cemented horizontally at the hinge pillar. That is incorrect.

Water entering at the top of the hinge pillar should flow to the outside via this weatherstrip. In this case it is quite the contrary. The water flows from the weatherstrip on to the scuff plate and collects there until it seeps into the interior.

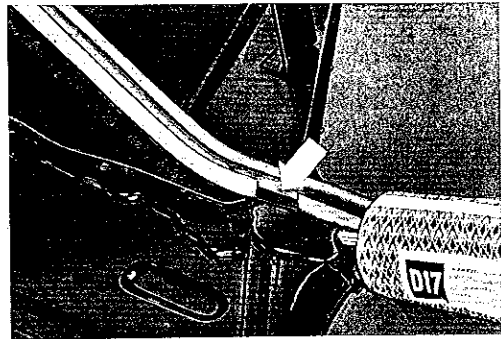
14/28 We start by spraying the weatherstrip between the body and the frame.

After some minutes water can be seen at the two points shown. Sealing the outside or inside with sealing compound has in the long run no lasting effect. The weatherstrip must be renewed.

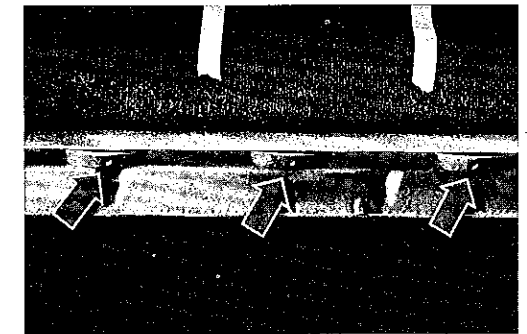
14/32 Before replacing the body on the chassis, straighten the mounting point surface, where, as you can clearly see here, it has become deformed by pulling up the body bolts.

Tighten all body bolts to the specified torque:

Bolts M 10 with 2 mkg (14 ft.lbs.)

Bolts M 8 with 1.2 mkg (9 ft.lbs.)

Whilst tightening watch the weatherstrip. If it becomes deformed do not tighten any further, otherwise you will damage the strip and further leaks will follow.

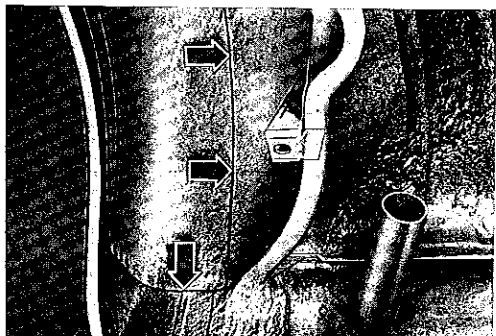
14/34 It is not always possible to make the metal sheets which lay within the spray range of the front wheels watertight.

Water which reaches the back of the hinge pillar cover plates should flow away through both the drain holes. As during construction only one hole is provided, it may be necessary in the case of leaks at the front fender to drill a further 10 mm hole as shown by the arrow.

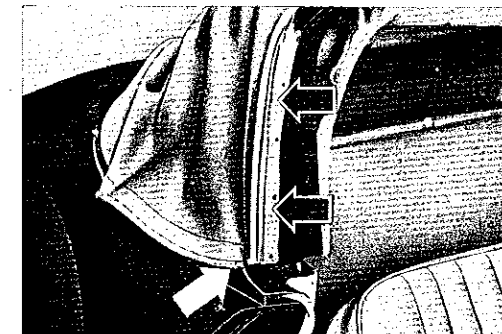
14/42 After about 20 minutes the top showed signs of leaks at the following points:

- 1 - The main bow
- 2 - The moulding over the rear window
- 3 - The rear support and
- 4 - Around the stitching of the rear window

14/43 The rubber seal on the main bow must be removed and the top cover re-mentented at the points shown by the arrows on the right.

It is also necessary to see that the top cover overlaps the rubber seal on the quarter panel when the top is in the closed position as shown by left hand arrow.

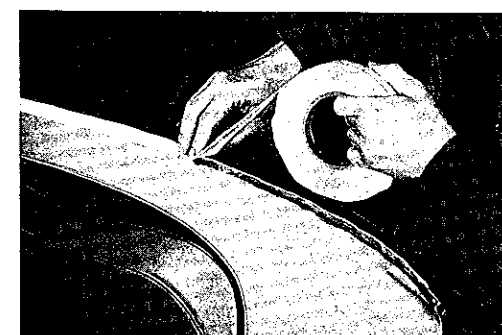
14/46 On this vehicle we must renew the rear portion of the top, because the seams around the rear window were leaking. In a case like this there is no possibility of repair.

After we have nailed on the new rear portion we apply adhesive D 12 all along the row of nails on the rear bow above the rear window. In order to stop the top cover from sticking at this point we apply a strip of linen over the adhesive.
