Body Leaks – Karmann Ghia Models

Slide Series No. 14

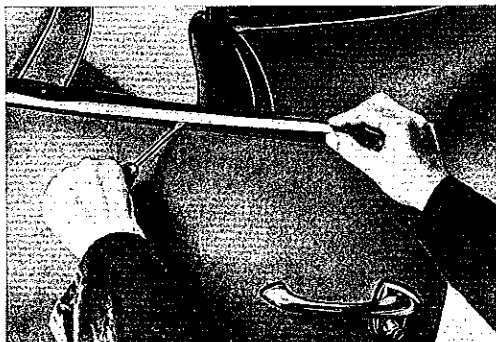
14/5 This weatherstrip is wavy and is not seated correctly on the glass. It must, therefore, be replaced. The removal and installation must be carried out carefully to prevent damage to the paintwork.

If the weatherstrip still does not seat correctly, correction should be carried out at the window channel.

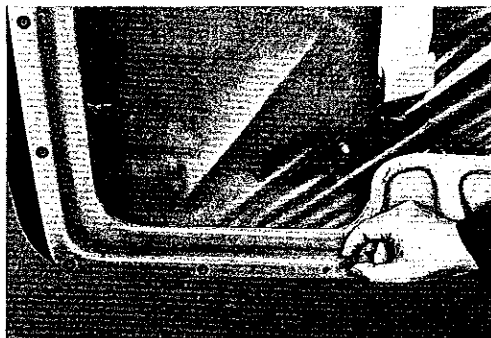
14/9 The holes for the trim panel clips are sealed with rubber caps. These rubber caps are used on the De Luxe Sedan for sealing the mouldings.

This will prevent water, which in heavy rain can collect in the bottom of the door, from reaching the interior of the car through the holes.

Install the door trim panel after carrying out the sealing operations.

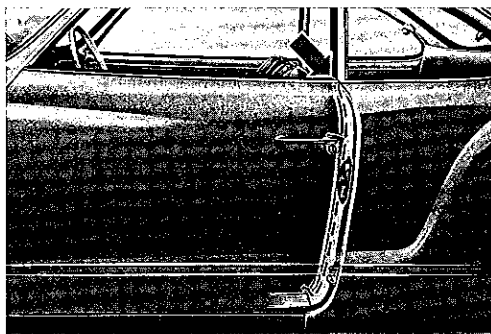
14/10 The small arrows on the lock pillar show the direction water will flow if it enters at the location indicated by the large arrow. If a leak occurs here, the carpet at the end of the scuff plate will become damp.

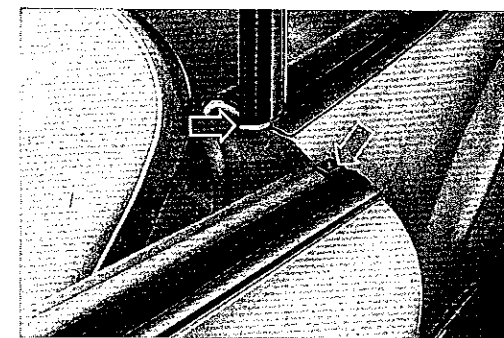
14/14 Water which runs down the lock pillar can drain off without entering the interior.

Since there is a drain hole under the scuff plate, the edge of the plate must be raised at the location shown here.

The mounting screws must, therefore, not be too tight.

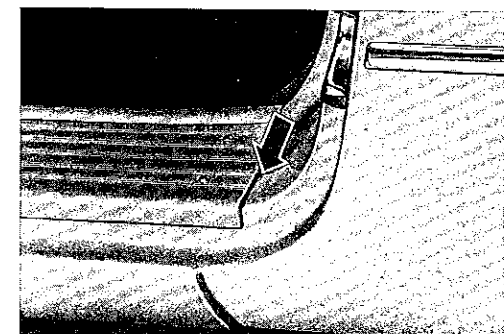
14/15 This can be clearly seen after the scuff plate has been removed: The water runs into the side member through the hole shown by the right-hand arrow. The next picture shows where the water goes to.

The sealing strip D 19 shown by the two left-hand arrows prevents the water from running under the scuff plate into the interior. It also provides the scuff plate with a slight inclination to the outside. Water which is blown on to the scuff plate when driving cannot enter the car.

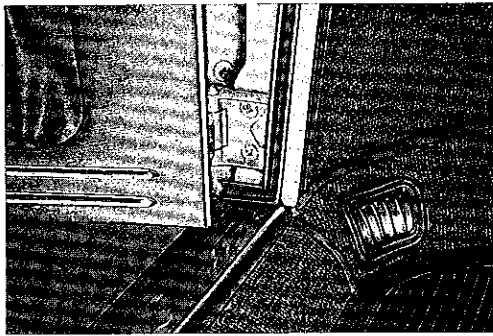
14/17 In this picture you see that the angled part of the weatherstrip is cemented horizontally at the hinge pillar. That is incorrect.

Water entering at the top of the hinge pillar should flow to the outside via this weatherstrip. In this case it is quite the contrary. The water flows from the weatherstrip on to the scuff plate and collects there until it seeps into the interior.

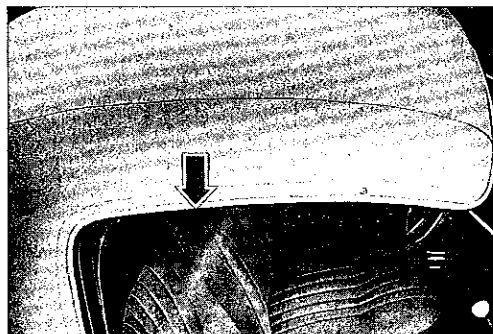
14/20 A further source of leaks is the adjustment of the door window on the Karmann Ghia Convertible.

If, however, the sides of the top have too much packing, leaks can occur at the top frame. In this case remove some packing.

If the window rubs against the top when opening the door, it is necessary to pack the side of the top until the door opens freely.

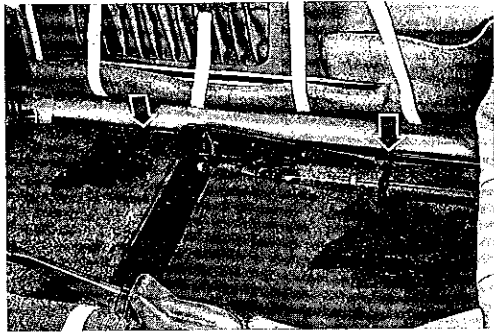
14/28 We start by spraying the weatherstrip between the body and the frame.

After some minutes water can be seen at the two points shown. Sealing the outside or inside with sealing compound has in the long run no lasting effect. The weatherstrip must be renewed.

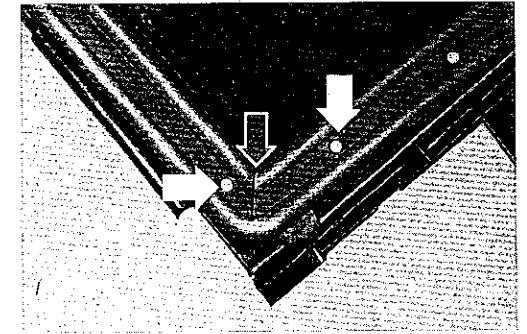
14/32 Before replacing the body on the chassis, straighten the mounting point surface, where, as you can clearly see here, it has become deformed by pulling up the body bolts.

Tighten all body bolts to the specified torque:

Bolts M 10 with 2 mkg (14 ft.lbs.)

Bolts M 8 with 1.2 mkg (9 ft.lbs.)

Whilst tightening watch the weatherstrip. If it becomes deformed do not tighten any further, otherwise you will damage the strip and further leaks will follow.

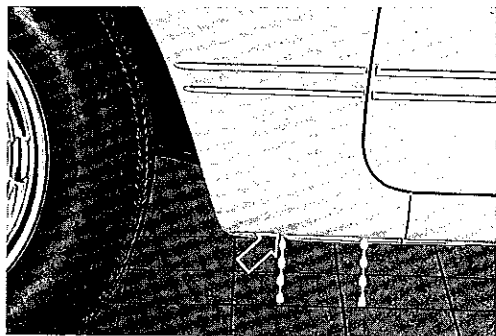
14/34 It is not always possible to make the metal sheets which lay within the spray range of the front wheels watertight.

Water which reaches the back of the hinge pillar cover plates should flow away through both the drain holes. As during construction only one hole is provided, it may be necessary in the case of leaks at the front fender to drill a further 10 mm hole as shown by the arrow.

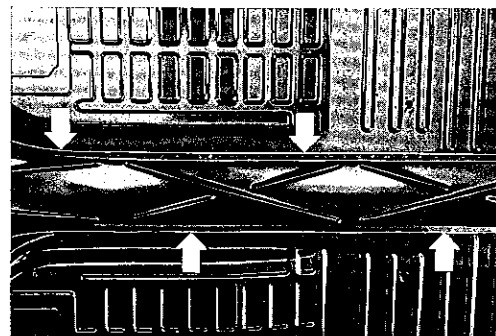
14/38 Next check the seams between the floor plates and frame tunnel. For this purpose the vehicle must be raised and a second mechanic equipped with a torch should watch the interior of the vehicle.

Leaks at the seams should be sealed from the outside with adhesive D 12 and then with sealing compound D 17.

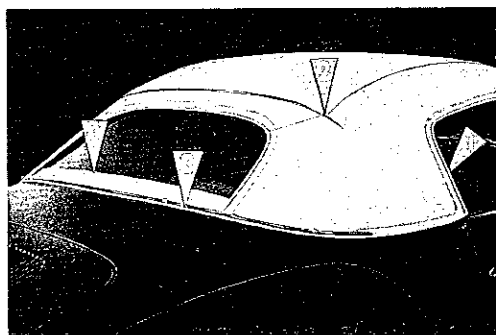
14/43 The rubber seal on the main bow must be removed and the top cover re-mentented at the points shown by the arrows on the right.

It is also necessary to see that the top cover overlaps the rubber seal on the quarter panel when the top is in the closed position as shown by left hand arrow.

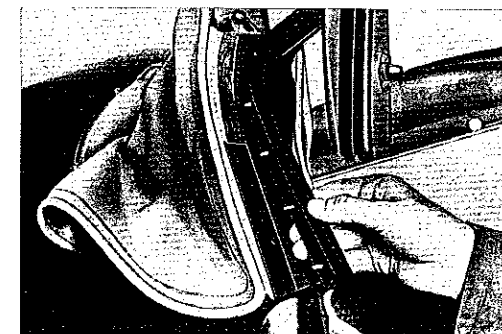
14/45 Secondly we will rectify the leak on the rear support. The cover must be completely removed from the rear support. In order to avoid damage to the paintwork, it is recommended that the rear of the vehicle be covered with a soft sheet. We next fill the gap between the rear support and the panelling with VW Sealing Compound D 17.

It is most important for this operation firstly to ensure that the rear support is screwed up tight.

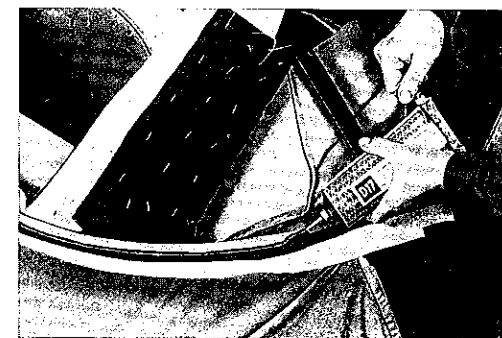
14/46 On this vehicle we must renew the rear portion of the top, because the seams around the rear window were leaking. In a case like this there is no possibility of repair.

After we have nailed on the new rear portion we apply adhesive D 12 all along the row of nails on the rear bow above the rear window. In order to stop the top cover from sticking at this point we apply a strip of linen over the adhesive.
